# **Access Audit Community Centre Armthorpe Parish Council Doncaster DN3 3AG**

**8<sup>th</sup> December 2025**

**About Access Ltd**

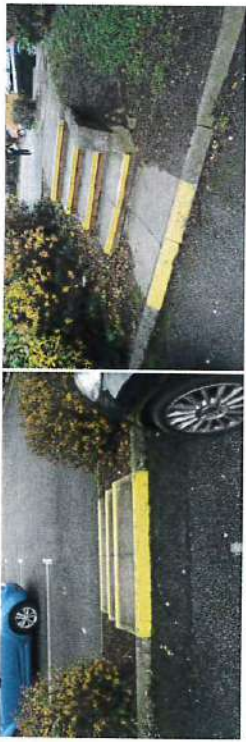
| Ref | Current Findings | Recommendation | Priority |
|---|---|---|---|
| 2.1 | <p>The general surface of the site is firm and even. As the site slopes down from the main road towards the entrance there are some steps between the parking areas. These have good tonally contrasting nosings. However, handrails have not been provided. Handrails should be provided to both sides of steps and they should extend horizontally beyond the top and bottom steps. Adding handrails that extend may be an issue as they will project into the parking spaces.</p> | <p>Provide handrails and if feasible extend horizontally beyond the top and bottom steps.</p> | 1 |
| | <p>An example of steps without handrails.</p> | | |

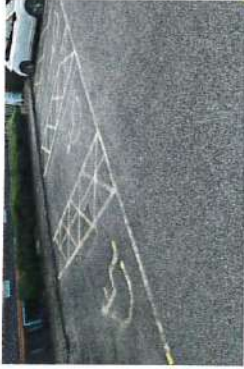
| Ref | Current Findings | Recommendation | Priority |
|---|---|---|---|
| 2.5 | <p>The accessible parking bays measure 2330 mm wide x 4900 mm long with 1170 mm wide hatching to the side. The recommended minimum size is 2400 mm wide x 4800 mm long with 1200 mm wide hatching to the side (preferably both sides) and the rear. There is wall mounted signage advising of the bays.</p> <p>The accessible parking bays.</p> | When remarking the bays provide the minimum recommended size and include hatching to the rear. | 3 |

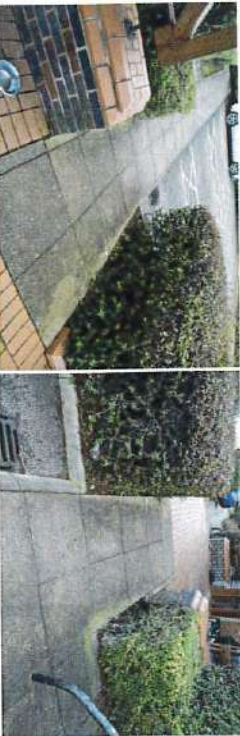
| Ref | Current Findings | Recommendation | Priority |
|---|---|---|---|
| 2.10 | On either side of the entrance ramp, there is a ramp from the path up to the entrance level. These have an indicative gradient of 1:8 – 1:9. No access routes should have gradients steeper than 1:12. | Investigate reducing the gradients to meet guidance. | 1 |
| | <p>The ramp at the side.</p> | | |

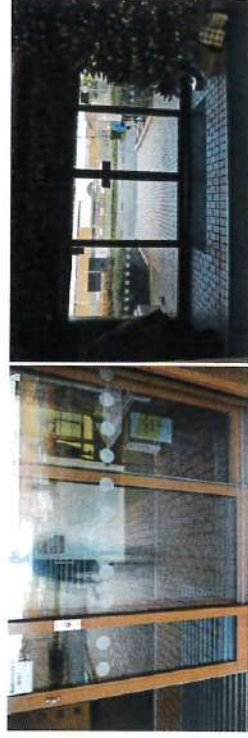
| Ref | Current Findings | Recommendation | Priority |
|---|---|---|---|
| 3.2 | <p>The entrance doors open on motion sensors and provide a clear width to allow access for all. The doors and side panels have large areas of glass. White circles at one height have been added for manifestation (permanent marking). Manifestation is there to help identify the glass and help prevent collision, especially if the doors are locked or not working correctly. When entering the circles are relatively easy to see but when exiting they can be lost in the background. It is recommended that manifestation of two tonally contrasting colours is used at two heights.</p> | Provide further manifestation that contrasts tonally to the existing in the height range of 1400 – 1600 mm above the floor. | 2 |

Manifestation to the entrance doors.

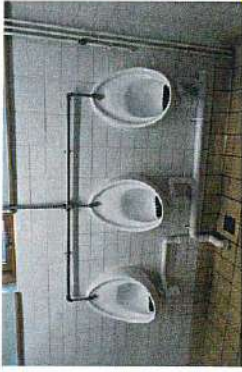
| Ref | Current Findings | Recommendation | Priority |
|---|---|---|---|
| 5.1.3 | <p>The urinals are all the same height.</p> <p>Modesty screens are not provided between the urinals. Some people will rest walking aids against them or even lean against them; they also provide privacy.</p> | Provide modesty screens between the urinals. | 3 |

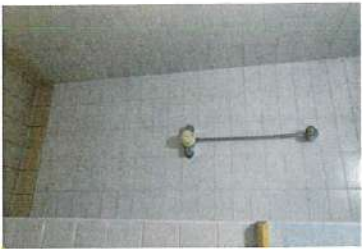
| Ref | Current Findings | Recommendation | Priority |
|---|---|---|---|
| 5.3.2 | There is a high threshold between the changing area and showers in the male changing room. This will create a barrier to access for people who cannot negotiate the threshold. There should also be an accessible shower and change facility. | Provide an accessible changing area with a shower. | P |

One of the showers.

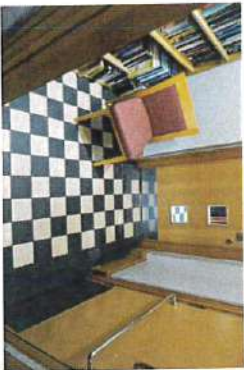
| Ref | Current Findings | Recommendation | Priority |
|---|---|---|---|
| 6.2 | <p>The floor of the lobby is a black and white chequerboard pattern. This type of pattern can be an issue for neurodivergent people and is generally not recommended.</p> | <p>When the opportunity arises, for example, in refurbishment, provide a floor covering that is not as visually noisy.</p> | 3 |
| 6.3 | <p>This is a visually noisy pattern.</p> <p>The room measures 1975 mm wide x 1770 mm deep. The width is the measured by which wall the toilet pan is attached to. Guidance recommends that accessible WCs should be at least 1500 mm wide (1700 mm preferred) and 2200 mm deep. The room is too small, which impacts the space wheelchair users, and others have to manoeuvre themselves. Although the room is too small, moving the WC pan so that it is on the wall opposite the door and placing the wash hand basin on the side wall in front of it would make it more accessible. Obviously increasing the room size would be preferable. See diagram "Appendix 8. Accessible WC for Independent Use - Plan" on page 51.</p> | <p>Investigate increasing the room size to 1700 mm x 2200 mm or larger. Failing that move the WC pan to the wall opposite the door.</p> | P |

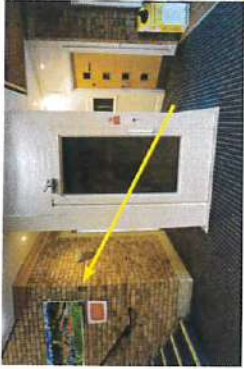
| Ref | Current Findings | Recommendation | Priority |
|---|---|---|---|
| 9.4 | <p>The signage to the toilets at the foot of the entrance hall stairs is not obvious.</p> <p>Signage is not easy to identify.</p> | Increase the visibility of the sign. | 2 |

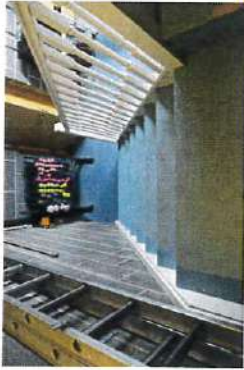
| Ref | Current Findings | Recommendation | Priority |
|---|---|---|---|
| 10.1.4 | <p>The stairs do not have tonally contrasting nosings. Nosings should be readily apparent, slip-resistant and have 30-point LRV difference to the treads and risers. On treads, they should measure 50 – 65 mm, and on risers, they should be 30 – 55 mm.</p> <p>Looking down the stairs with no tonally contrasting nosings and a single handrail.</p> | Provide tonally contrasting nosings. | 1 |

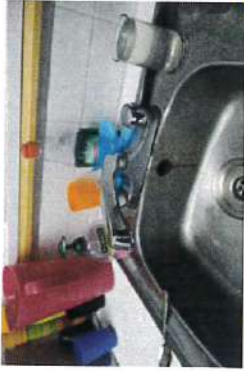
| Ref | Current Findings | Recommendation | Priority |
|---|---|---|---|
| 13.1 | The sink next to the office has twist-action taps that require a person to grip and twist their hand to turn. It is recommended that it should be possible to operate taps with the use of a clenched fist. | Provide taps that can be used with a clenched fist. | 3 |
| | <p>Sink next to the office.</p> | | |
